## **STABILIZING LANDSLIDES USING RAMMED AGGREGATE PIERS**

**Han Khee Kwong<sup>1</sup>, Bon Lien<sup>2</sup>, and Nathaniel S. Fox<sup>2</sup>**

<sup>1</sup> Ikram Runding Sdn. Bhd., Malaysia, <sup>2</sup> Geopier Global Corporation, USA.  
<sup>1</sup> [dr\\_hankk@hotmail.com](mailto:dr_hankk@hotmail.com) <sup>2</sup> [geopier6@aol.com](mailto:geopier6@aol.com)

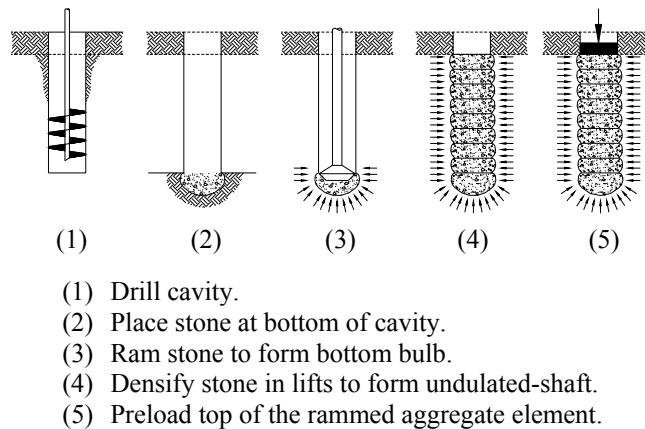
**Figure 1: Construction Process**

Construction of rammed aggregate pier elements is well described in the literature and shown in Figure 1 [2], [3], [4], [5]. The piers are installed by drilling 610 mm to 915 mm diameter holes to depths typically ranging between 2 m and 8 m below working grade elevations (Figure 1, Panel 1), placing thin lifts of aggregate stone within the cavities, and compacting the aggregate using a specially designed high-energy beveled impact tamper. The first lift consists of clean stone and is rammed into the soil to form a bottom bulb below the excavated shaft (Figure 1, Panels 2 and 3). The bottom bulb effectively extends the design length of the aggregate pier element by one pier diameter. The piers are completed by placing consecutive 0.3 m thick lifts of aggregate over the bottom bulb and densifying the aggregate with the

beveled tamper (Figure 1, Panel 4). During densification, the beveled shape of the tamper forces stone laterally into the sidewall of the excavated cavity. This action increases the lateral stress in the matrix soil thus providing additional stiffening and increased normal stress perpendicular to the perimeter shearing surface. The final step is a preload application, applying a downward force on top of the completed pier for a preset period of time. This preload effectively prestresses and pre-strains the pier and adjacent matrix soils and further increases the stiffness and capacity of the system.

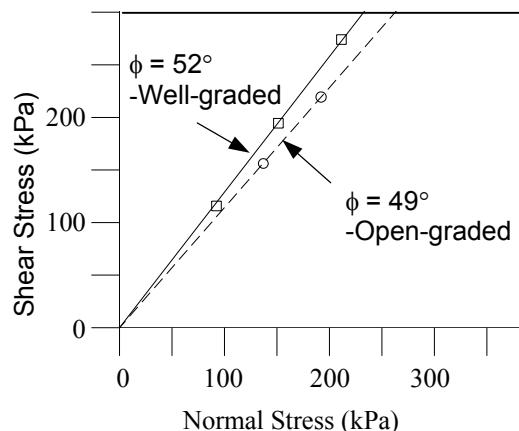
**Figure 2: Results of full-scale direct shear tests**

Full-scale direct shear test results, shown on Figure 2, indicate a friction angle of about 49 degrees for piers constructed from open-graded stone (no fines) and a friction angle of about 52 degrees for piers constructed from well-graded stone (5 to 10 % fines). Laboratory triaxial tests indicate a friction angle of 51 degrees for piers constructed from well-graded stone.

This paper discusses the construction process of the rammed aggregate pier system and design methods using this soil reinforcing elements for stabilizing landslide and improving global stability. The high shear strength, with an internal friction angle ranging from 49 to 52 degrees, exhibited by the aggregate pier elements, allows for substantial increases in the composite shearing resistance within slopes, thereby providing higher global factors of safety against instability. Case histories are presented where the rammed aggregate pier elements have been successfully used to provide economical solutions for difficult landslide stabilization problems.

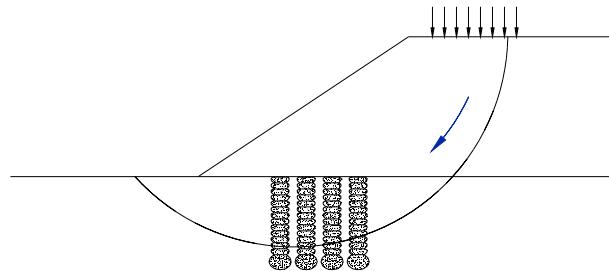
**Figure 3: Global stabilization using rammed aggregate pier elements**

The unusually high internal shearing resistance of the rammed aggregate pier elements contributes to soil reinforcement and to stabilizing failing slopes. Rammed aggregate piers reinforcing elements are installed to intersect potential critical shearing surfaces thereby increasing the factor of safety against global instability (Figure 3). Analyses of the factor of safety against instability are performed using conventional geotechnical slope stability computer programs [9].

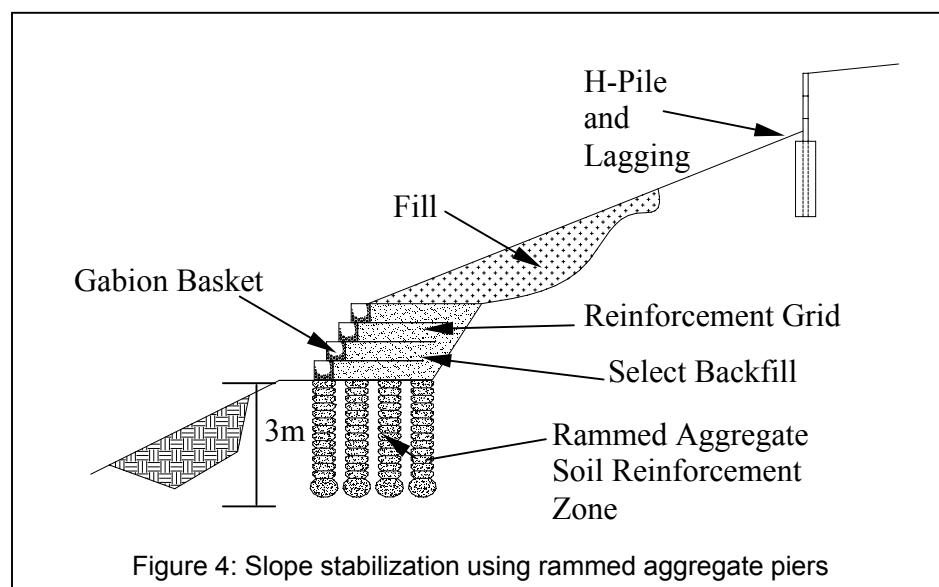
In lieu of the planned excavation, rammed aggregate pier elements were installed to support the gabion wall (Figure 4). The 3-m long piers extended through the critical failure surface of the slope. Attributing to the very high friction angle of the rammed aggregate (on the order of 50 degrees) installation of aggregate piers within weak matrix soils increases the composite shearing resistance of the reinforced zone. Also, lateral compaction during construction provides increases in both shear strength and stiffness modulus of the matrix soil between the rammed aggregate pier elements. Figures 5 and 6 illustrate the pier construction at the site and the final constructed slope, respectively. As a result of rammed aggregate pier installations, construction risks and costs associated with the slope repair were reduced and the construction schedule was accelerated in comparison with alternative repair options.

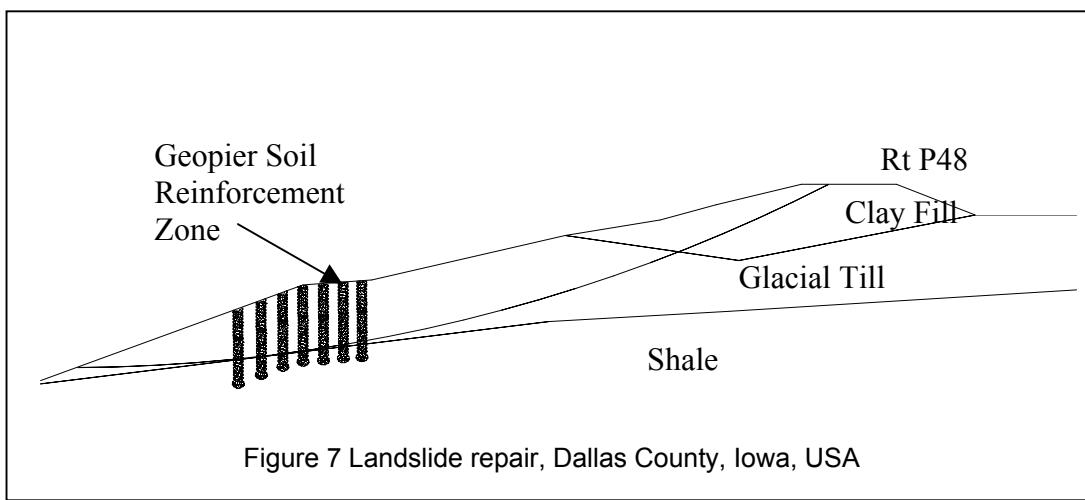
In order to prevent further movement of the slide, it was essential to increase the shearing resistance of the weak shale layer. A total of 579 rammed aggregate pier elements were installed to depths of up to 9 meters (Figures 7 and 8). The piers were installed into the weak shale layer to strengthen the weak interface between the shale and the overlying soil. To minimize problems with groundwater infiltration within the pervious piers, a 1.5-m clay cap was constructed in the upper portion of each pier. The rammed aggregate pier soil reinforcement solution resulted in a cost of US\$170,000. This represented a cost savings of US\$700,000 relative to the other considered solutions.
