## Ductile Iron Piles Corrosion Resistance

# DUROTERRA

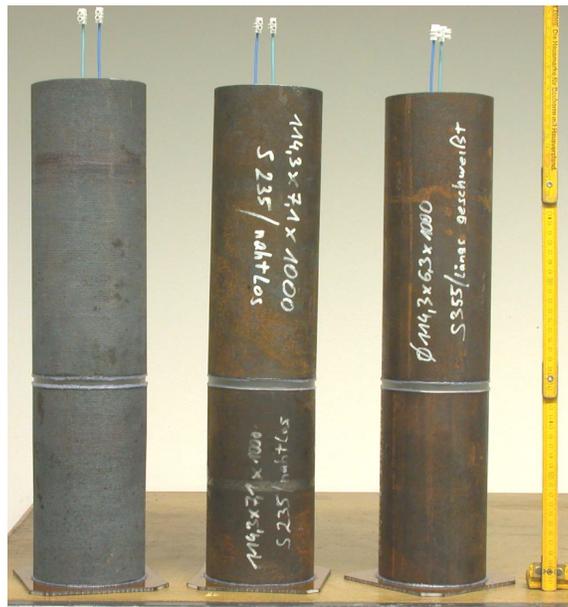
Figure 1: Picture of Samples prior to Testing

Similar dimensioned samples of Ductile Iron Pile, and European S235 steel (ASTM A284 equivalent) and European S355 (ASTM A633, A656 equivalent) were selected (Figure 1). The samples were placed into a controlled environment consisting of compact sand in the lower portion and gravel in the upper portion as shown in Figures 2 and 3. The container was filled with an electrolyte (deionized water and dissolved salts). The electrolyte was routinely flushed with aerated water, but only in the upper portion to increase oxygen exposure. The compact sand environment models a stagnant, low oxygen environment while the gravel (upper) environment models a high-oxygen condition with routine flushes of the electrolyte. As a result of the test setup, the aerated (upper) section models an oxygen reduction reaction while the non-aerated (lower) section models anodic metal dissolution.

Figure 4 shows a picture of the prepared samples prior to introduction to the test device: Ductile Iron Pile, S235 steel, S355 steel (left to right). Figure 5 shows a picture of the samples following removal from the test environment.

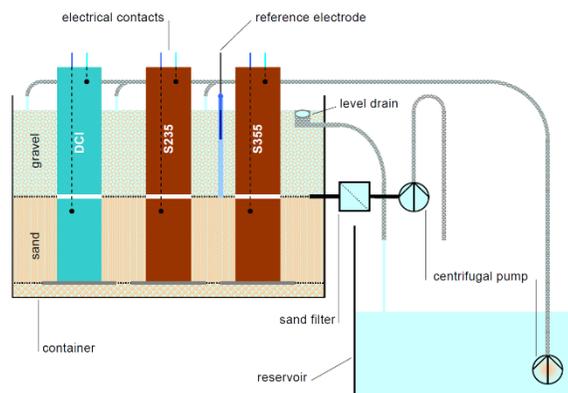
Figure 2: Schematic of Test Setup

The test setup included instrumentation including shunt resistors, a reference electrode and a data acquisition system to record the corrosion current between the sections and the corrosion potential. Tests were performed continually over the course of 441 days to evaluate the effects on the samples.

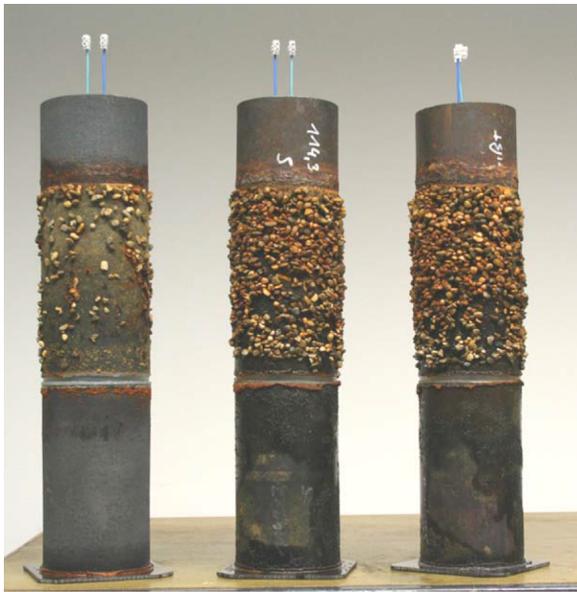
**Figure 4: Picture of Samples after Testing (pre-cleaning)**

the pile surface and the pebble were few. The behavior in the lower anaerobic portion of the setup was dictated by anodic reaction created by the electrical contact with the cathodic upper portion. This anodic reaction caused metal dissolution at localized areas thereby reducing the effectiveness of the corrosion passivation. However, this behavior resulted in only shallow, localized pitting of the skin.

In contrast, the steel samples behave as an actively corroding metal. The rolling skin from the manufacturing process offered far less protection than the Ductile Iron casting skin, resulting in a more wide-spread pattern of corrosion evidenced by the nearly complete coverage of pebbles to corrosion locations (Figure 5). The development of this corrosion layer does have a benefit by acting to reduce the access to oxygen and reduce continued corrosion with time only after substantial corrosion has occurred. The presence of the electrical current created by coupling with the upper section intensified the corrosion and the dissolution of the rolling skin in the lower portion.

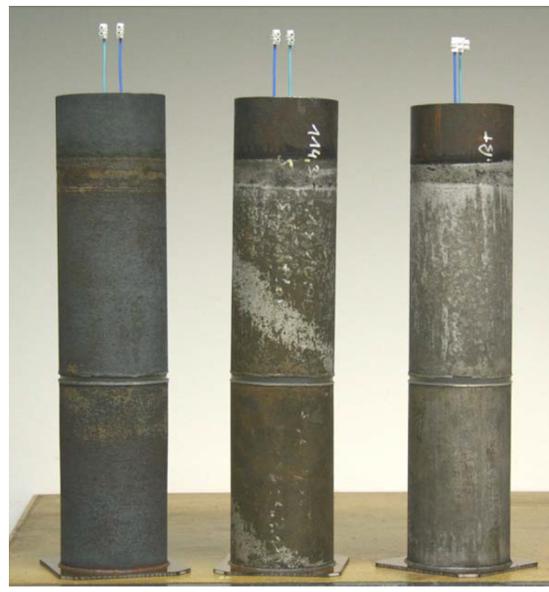
**Figure 5: Picture of Samples after Testing (post-cleaning)**

In summary, the Ductile Iron Pile exhibits superior corrosion protection. The ductile pile material performed better than steel in the simulated corrosive environment with only localized areas of corrosion product and shallow pitting – a vast difference compared to the overall performance of the steel sections.
